**Environmental Site Assessment
Transaction Screen
for the
Old Shooting Range Site
on the
Lower Brule Sioux Reservation**

Draft April, 2018

EXECUTIVE SUMMARY

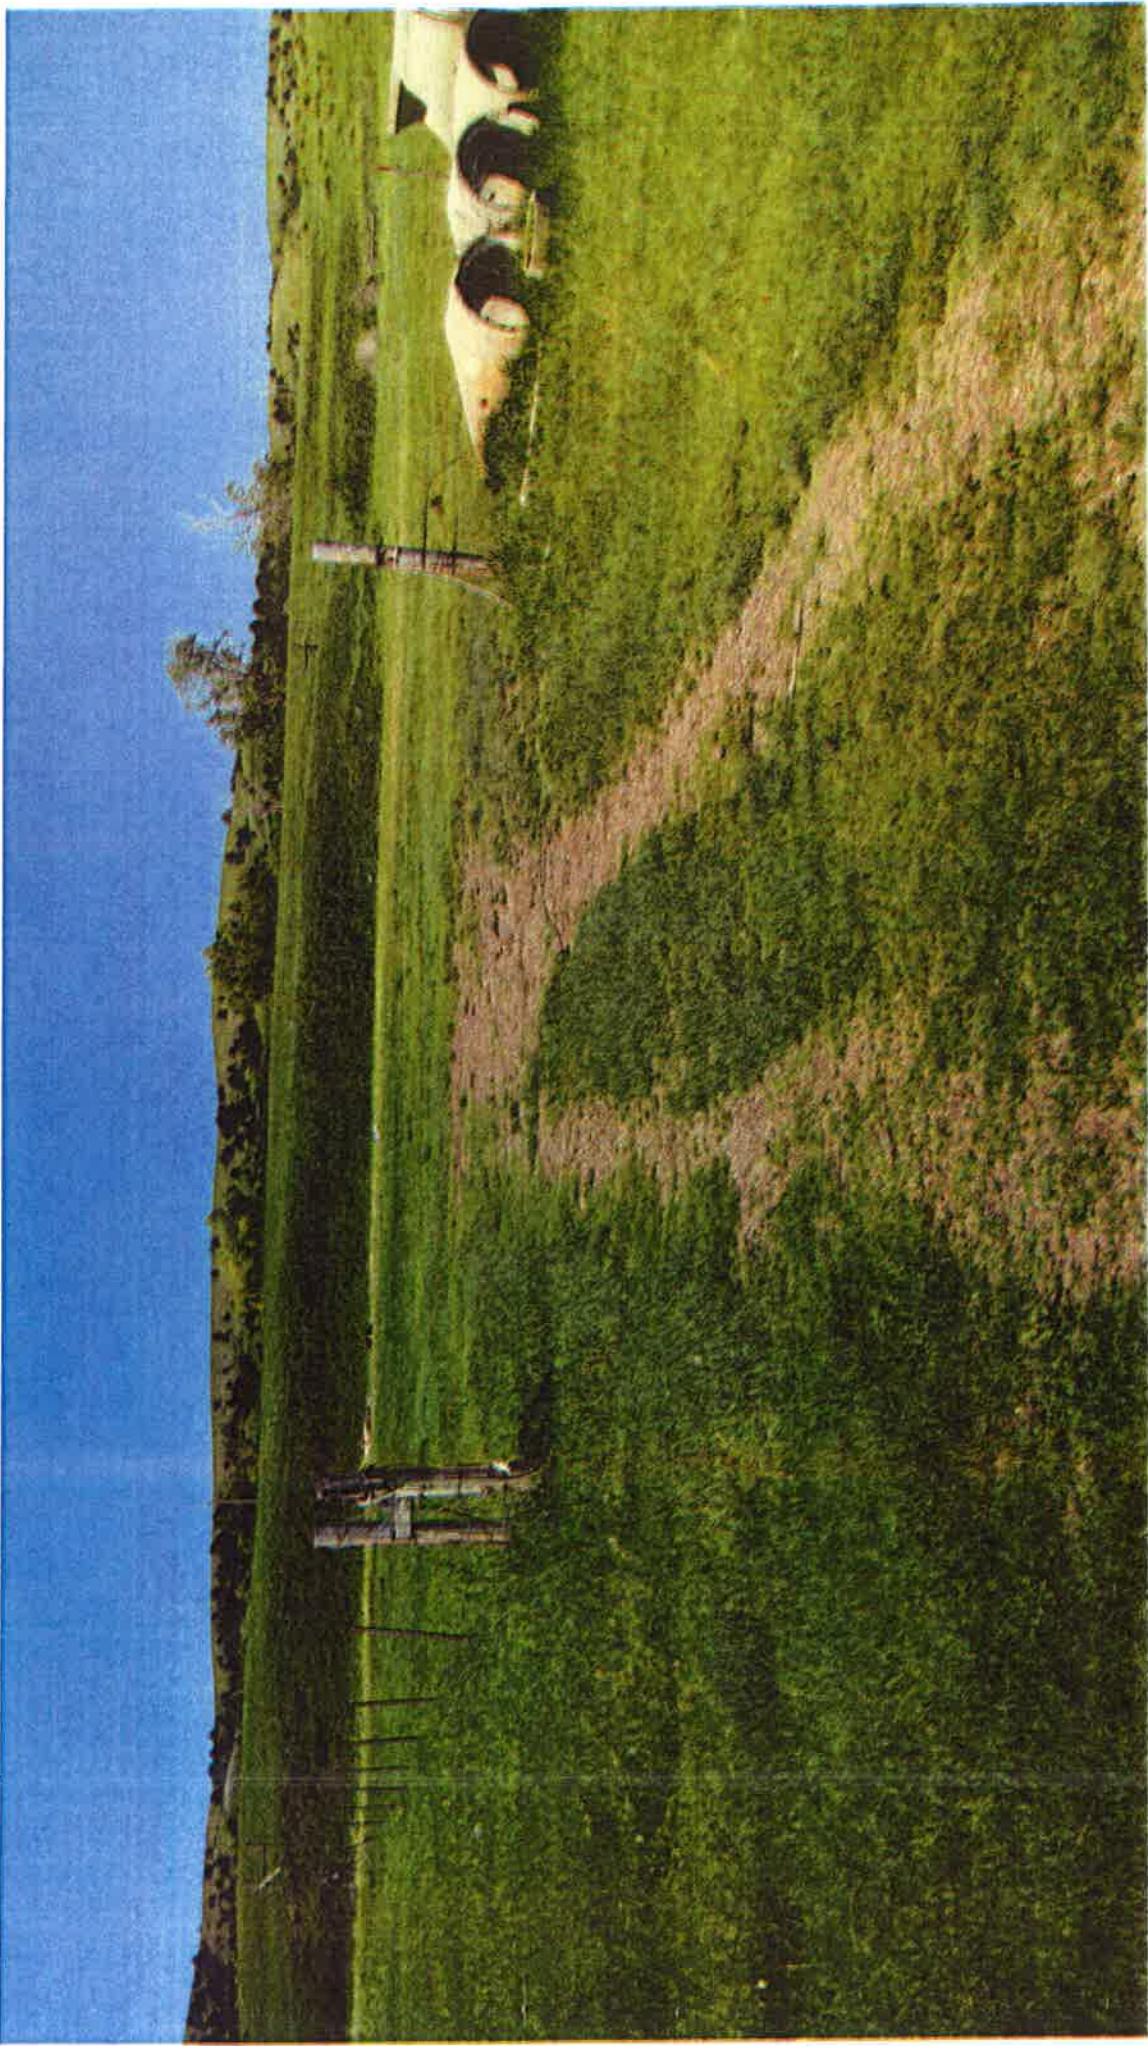
There are no buildings or structures on this site. The 2.5 acres is fenced. There is a bank or berm on the northwest side where targets were placed for practicing shooting. The berm is about 10 feet high.

5-3-18 Berm

It is recommended that a Phase II Site Assessment be conducted for the Old Shooting Site because of potential lead contamination.

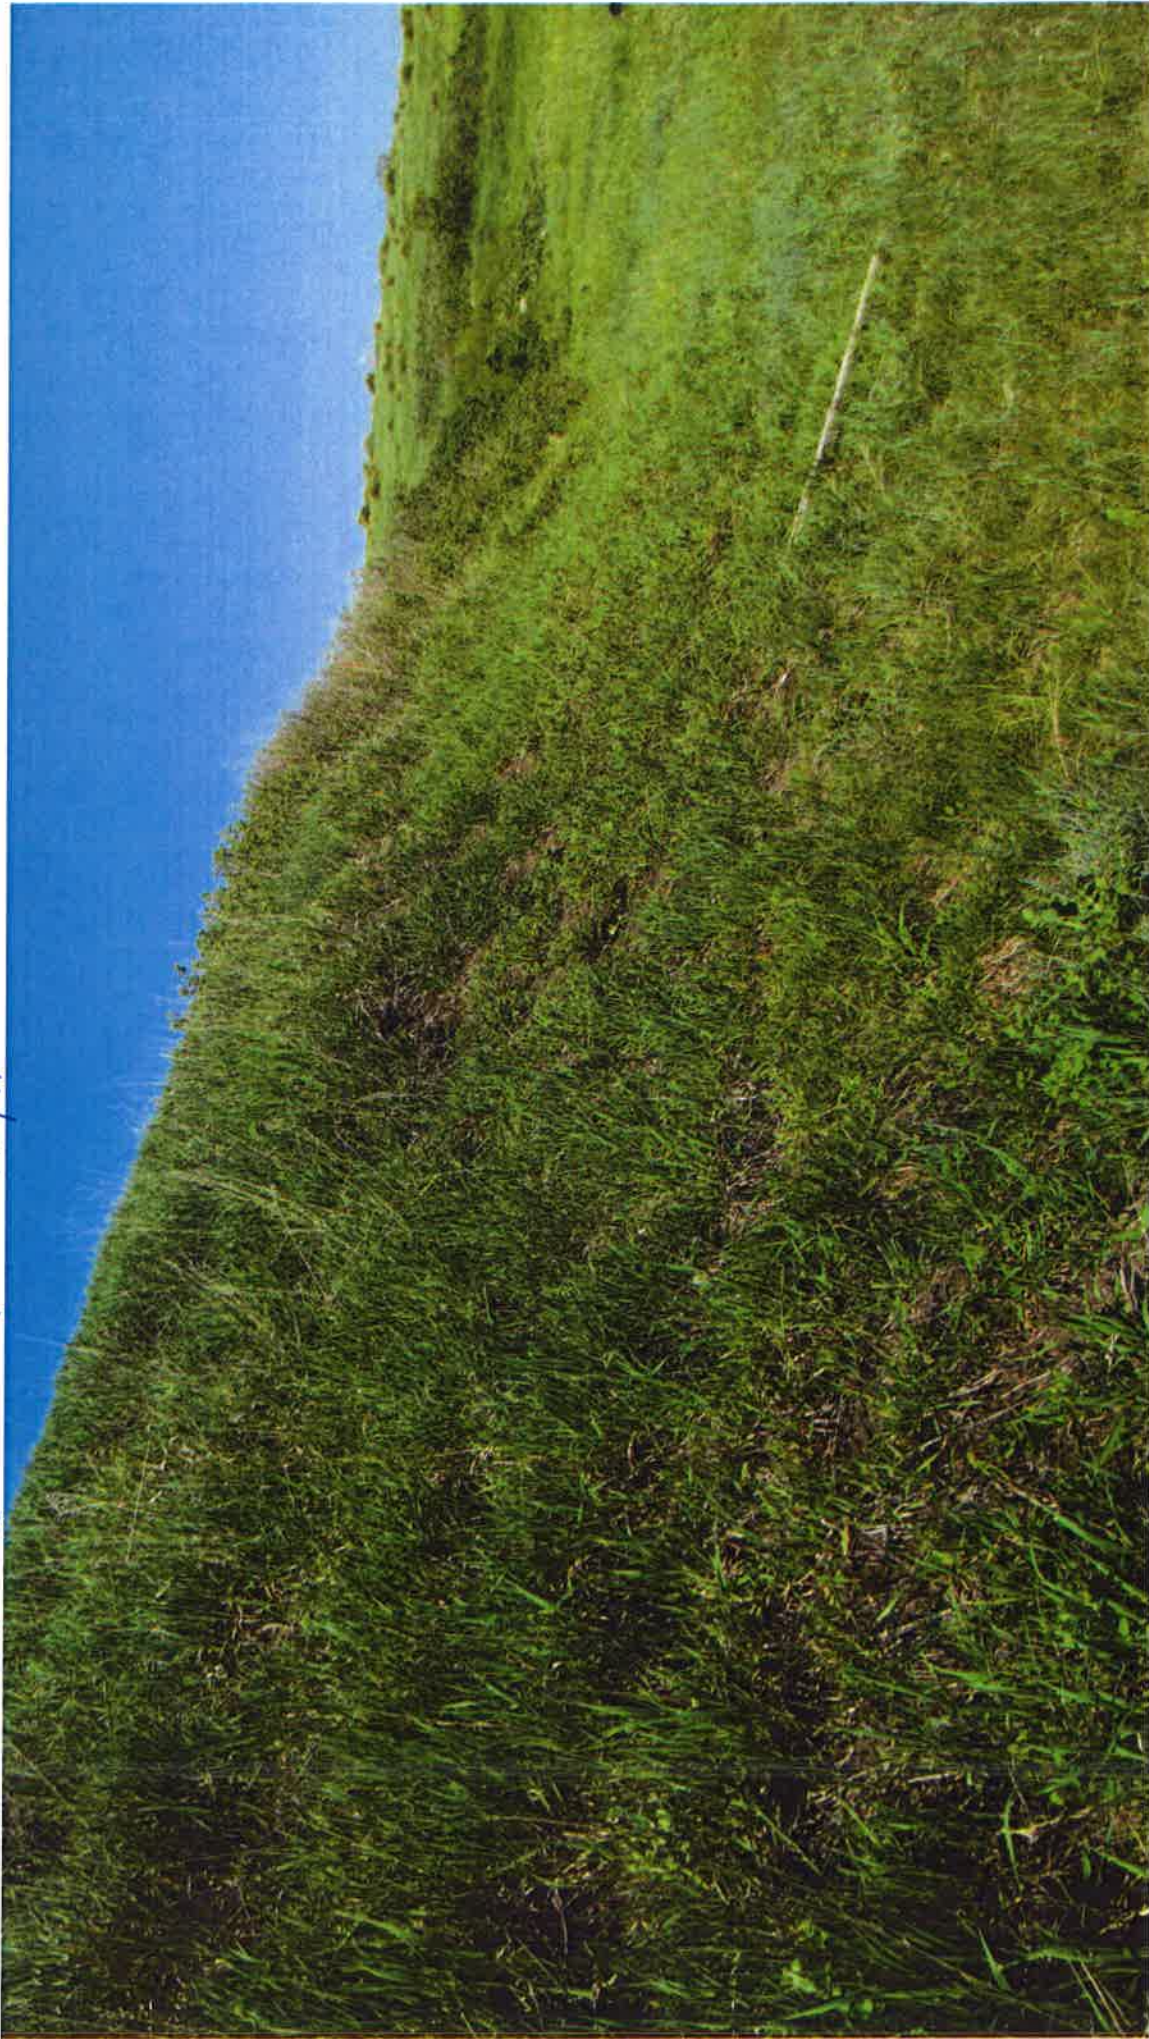
5-3-18 Berm, about 10 feet high
